INTERACTION OF COPPER-CONTAINING RO-  
TATING BAND METAL WITH GUN BORES AT  
THE ENVIRONMENT PRESENT IN A GUN TUBE

R. S. Montgomery

Watervliet Arsenal  
Watervliet, New York

June 1974

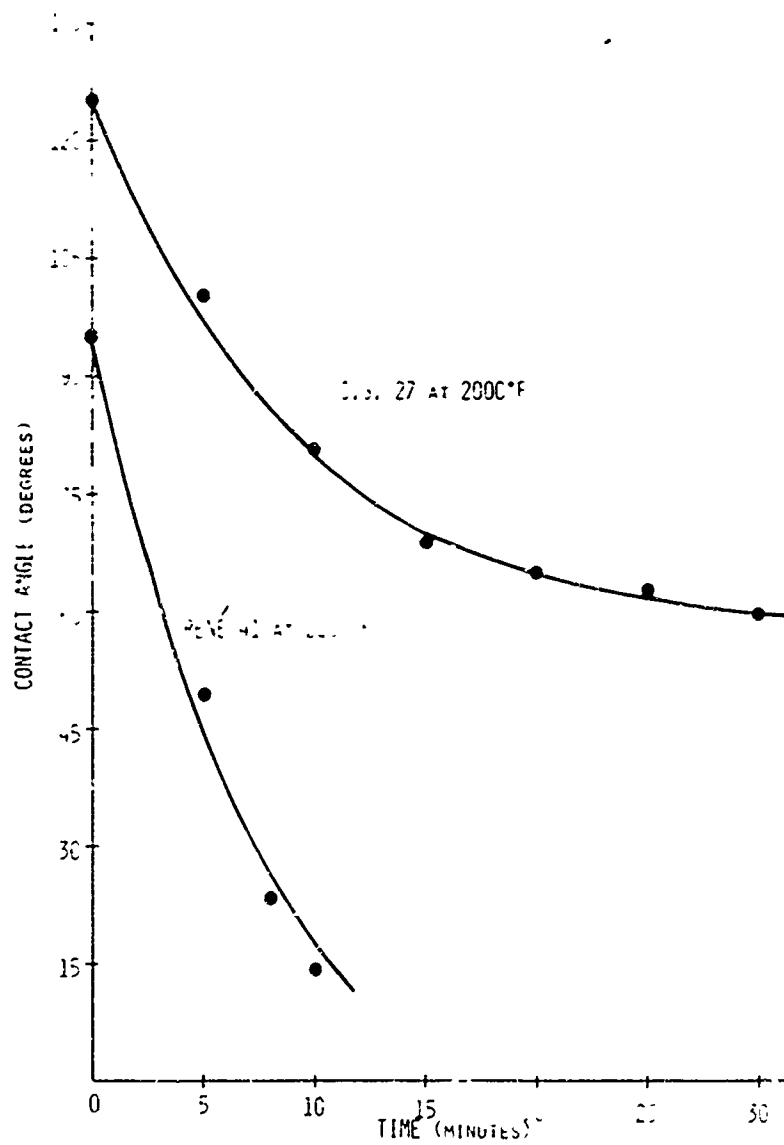
FIG. 3 Contact angles with molten copper as a function of time.

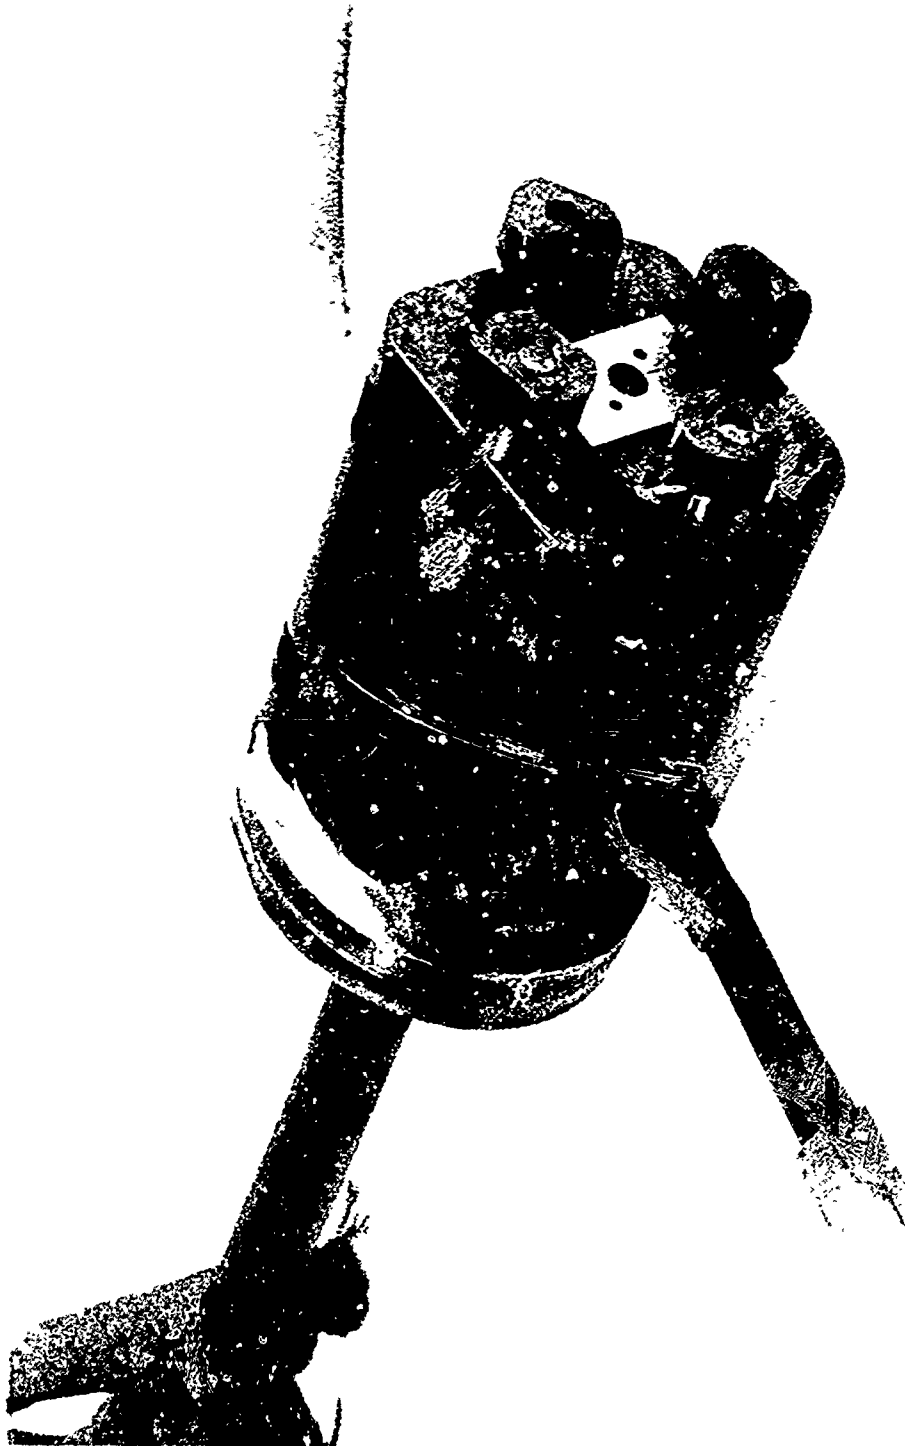
FIG. 10 Assembled test device affixed to the muzzle of an M-16 rifle.

The two test specimens were held together and in place by a taper ground on their reverse sides fitting into a mating taper in the holding fixture. The holding fixture was then bolted to a water-cooled flange which was screwed onto the rifle muzzle in place of the flash suppressor. Water-cooling was used to minimize any deterioration of the rifle barrel or interaction with the gilding metal before the bullet reached the test alloy and to eliminate the possibility of a "cook-off", i.e. discharge of the weapon owing to a high chamber temperature. The temperature of the test specimen was measured at a location near the exit end of the test bore by means of an iron-constantan thermocouple. A temperature measurement at this point will assure that the temperature of the specimen is sufficiently high and that it is similar from experiment to experiment but it will not measure the temperature at the entrance of the test bore. Before firing, this temperature will be considerably below the measured temperature owing to the heat-sink action of the water-cooled flange. It will, however, rapidly increase during the firing. The bore surface temperature can probably be best estimated by metallographic examination of the metal after the experiment.

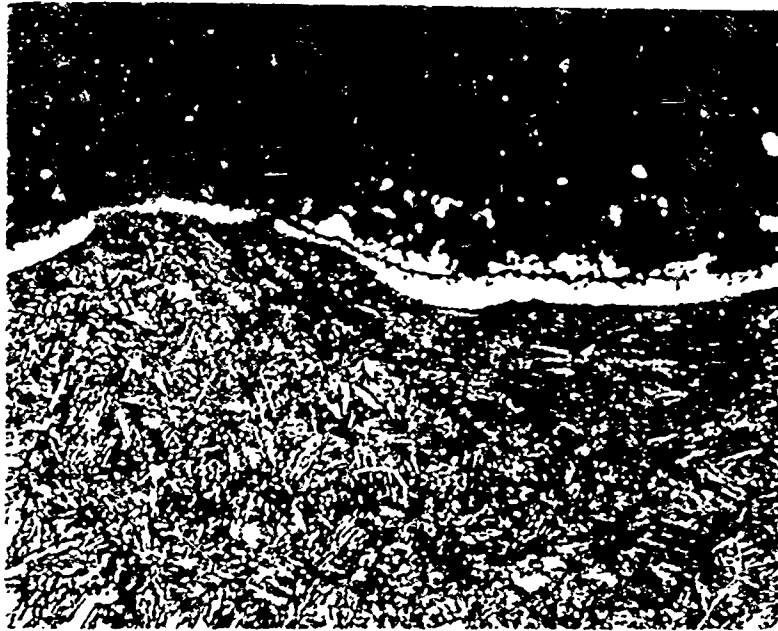
FIG. 16 Section through the eroded zone of a 4340 steel specimen showing thin layer of worked metal at the surface. (100 X)

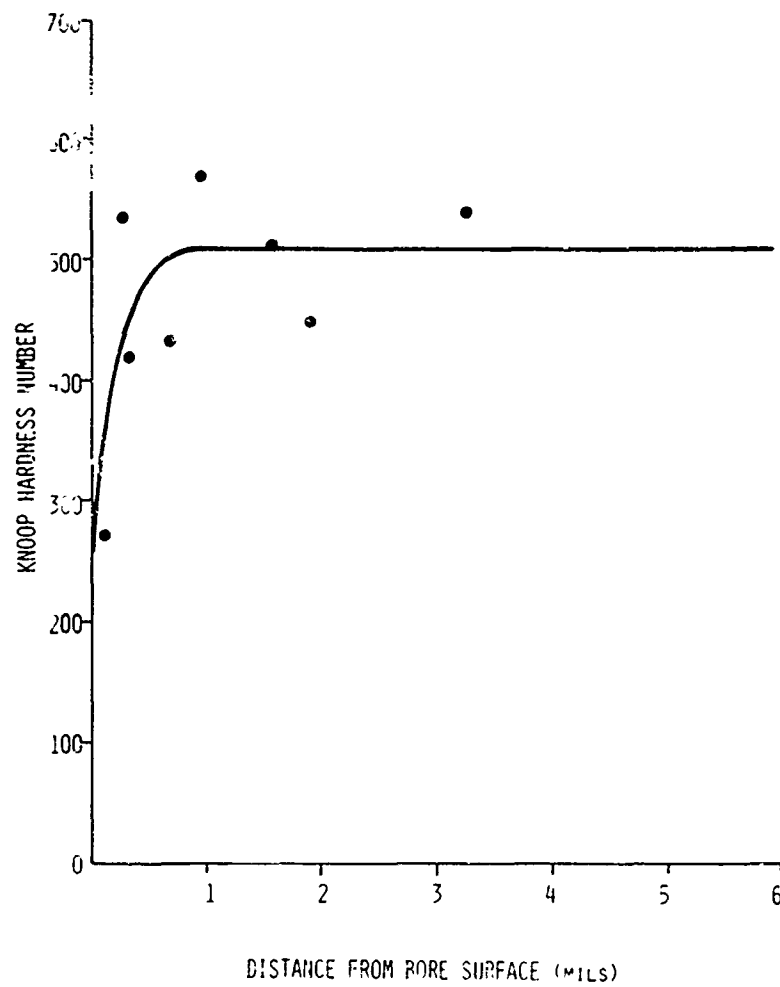
FIG. 17 Hardness through 4340 steel beneath the eroded zone as a function of distance from bore surface.

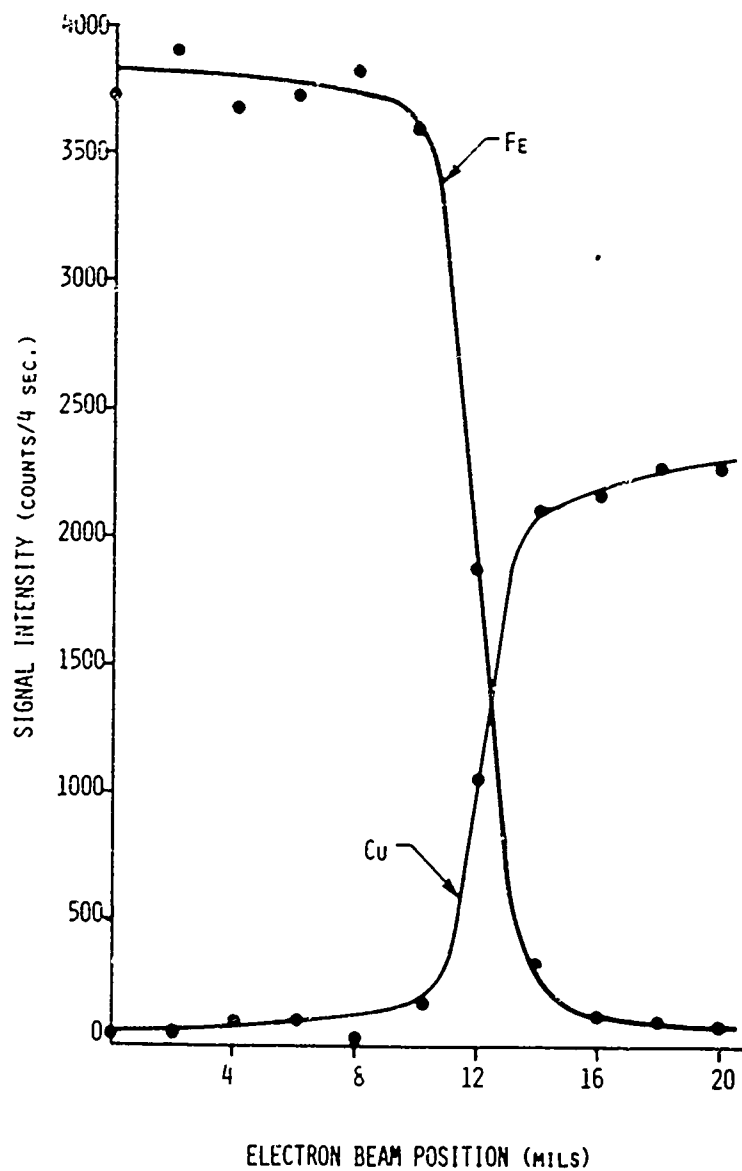
FIG. 18 X-ray intensities characteristic of iron and copper across a section through the eroded zone of a 4340 steel specimen showing lack of interpenetration .

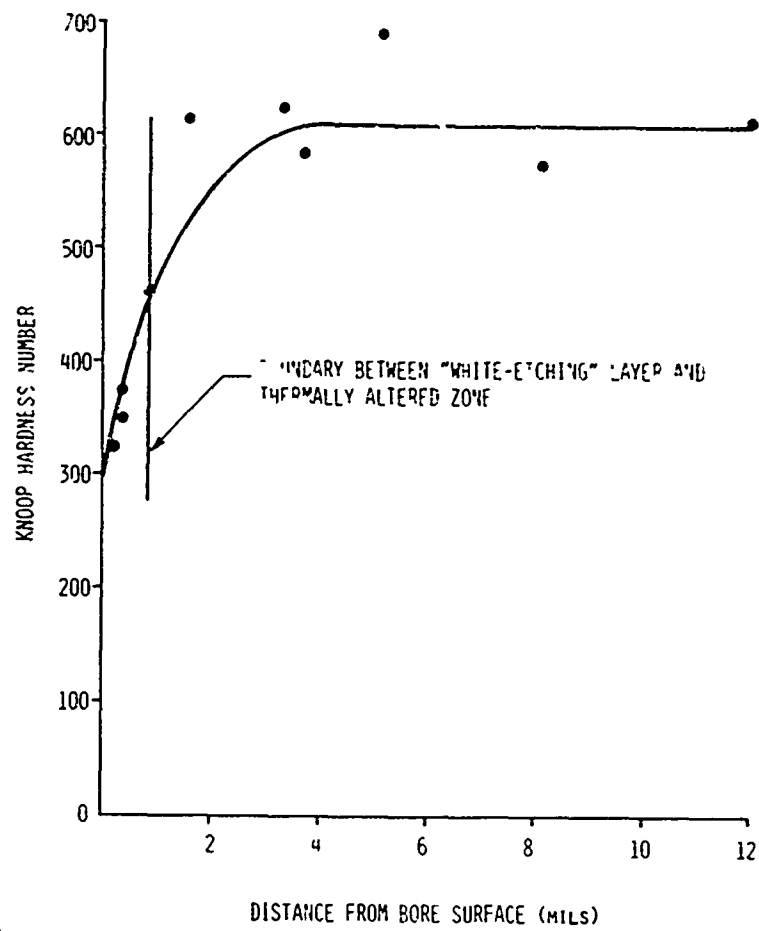
FIG. 20 Hardness through Pyromet X-15 beneath the eroded zone as a function of distance from bore surface.

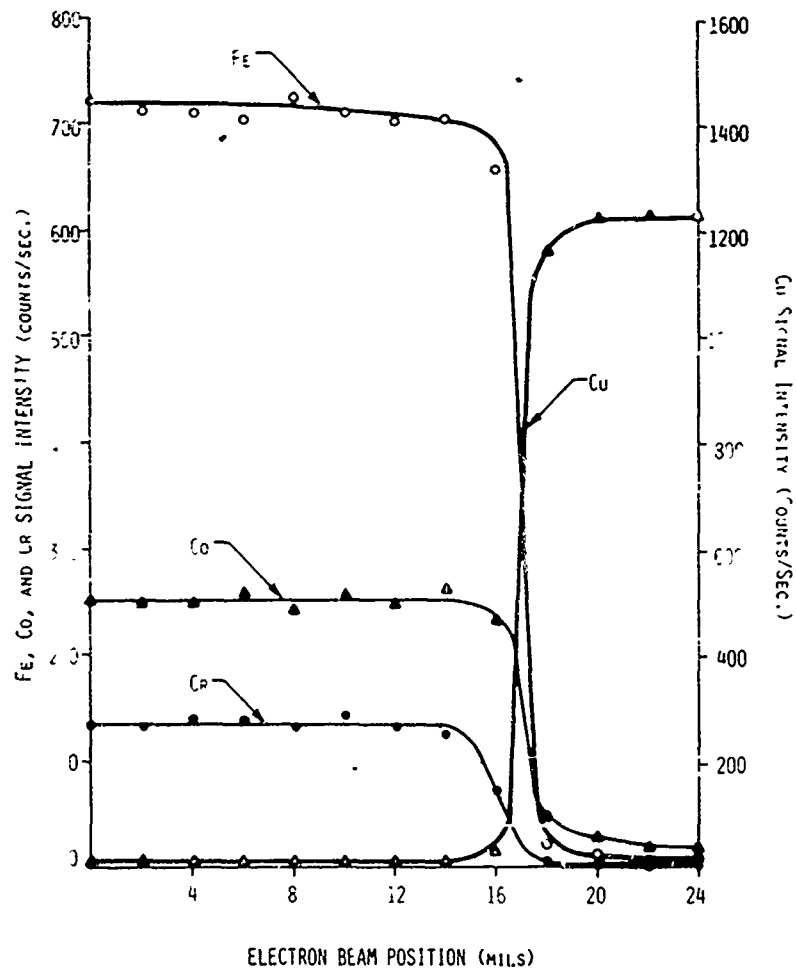
FIG. 22 X-ray intensities characteristic of iron, cobalt, chromium, and copper across a section through the eroded zone of the Pyromet X-15 specimen showing lack of interpenetration.

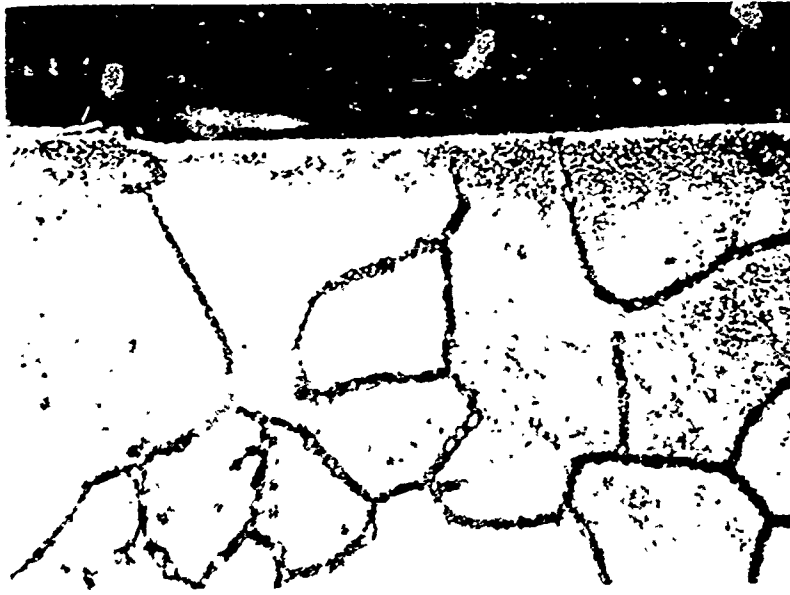
FIG. 23 Section through C.G. 27 specimen at the eroded zone showing thin "white etching" layer. (1000X)

about 100 microinches) and the surface grains appeared somewhat elongated in some locations. (See Fig. 23.) Other than this, there were no changes in the microstructure as a result of the firing. Furthermore, there was no electron microprobe evidence for any interaction between the molten gilding metal and the C.G. 27.
